# Elimination of Soot and Rust from Nozzle Body In Order To Improve Quality and Productivity

Sagar Sonawane<sup>†\*</sup> and Poonam Walke<sup>‡</sup>

Accepted 12 March 2017, Available online 16 March 2017, **Special Issue-7 (March 2017)**

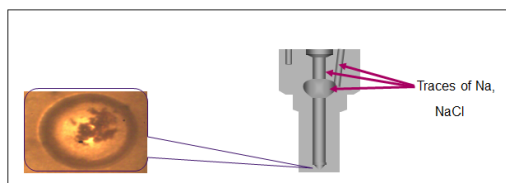
Fig.2 NA and NaCl melting theory

- 1) Theory put was uncleaned Na, NaCl at Pressure chamber, guide bore, inlet -hole melts during Carburizing process and due to gravity gets deposited at sac hole.
- 2) This molten solution gets contaminated with the soot particles generated in Carburizing and solidifies after process.
- 3) This solidified material remains in sac hole and does not get removed on aqueous Cleaning, and gets rejected as soot/rust in Hard Stage.
- 4) Carburizing temp. - 920°C, Melting point of NaCl - 801°C, Vaporising point of NaCl - 1400°

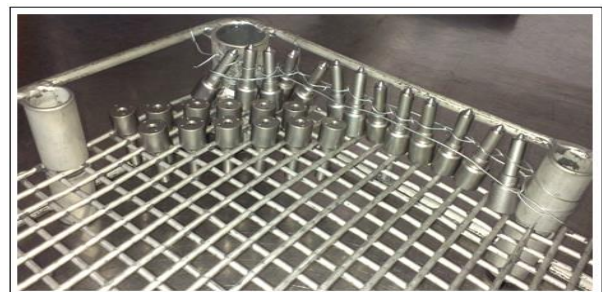
Fig.3 Part loading for validation trial

- 1) 50 DSLA bodies after Aqueous Cleaning machine (Visually checked for NaCl traces) loaded in UDA for Carburizing.
- 2) And another 25 parts in seat side up position as shown in figure 3.6
- 3) 25 parts in normal loading position (Seat side down) as shown in figure 3.7 which
- 4) Figure 3.4 shows actual loading condition of trial
- 5) Result: From validation trial .25 parts which kept seat side up condition was clean after carburizing process. Because soot or molten metal which generate during carburizing process in this parts get fallen down due to gravity
- 6) And for another 25 parts which kept in normal condition was full of soot and rust because soot gravity effect soot falls down in to the sac hole and seat area as shown in figure

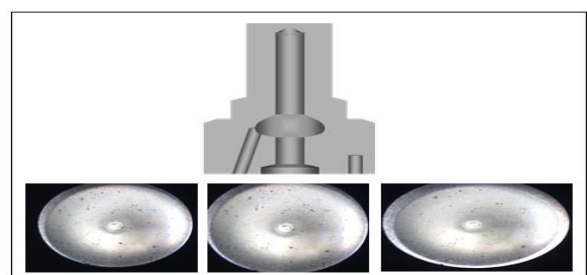
Fig.4 Parts with seat side up loading (Cleaned parts)

- 1) For revalidation 25 parts takes places for hardening which were not okay in validation trial
- 2) Apart from 25 parts 13 parts loaded in seat side up position as shown in figure
- 3) And 12 parts again loaded in normal loading position (Seat side down) as shown in figure
- 4) Results: From above revalidation trial again parts which were loaded in normal loading condition were full of soot and rust and parts which were loaded in seat side up position were clean
