## Static and Fatigue Failure Analysis of Rear Trailing Arm (Case study at MIE)

This paper presents failure analysis and modeling of the rear trailing arm case study at Mesfin Industrial Engineering, Ethiopia. Considering loading type as 1G, 2G and 3G bump load condition, the static and fatigue analysis were carried out using SOLIDWORKS simulation finite element analysis. The maximum von Mises stress and static factor of safety for existing rear trailing arm in 3G bump load condition were 537.5MPa and 0.44 respectively. The endurance limit of the component 180MPa is lower than the alternative stress of 268.67MPa. Due to less factor of safety, the existing rear trailing arm failed statically and dynamically. From the analysis of the result, St-52 was chosen over St-37. The von Mises stress and factor of safety under 3G bump load condition for St-52 were 128.1MPa and 2.77MPa respectively. Hence, the design is statically safe. Fatigue analysis was also carried out for the 3G bump load of modified design of Rear Trailing Arm made of St-37, St-44 and St-52 material for thickness increased 2mm to 5 mm materials. The endurance limit of the component for St-52 is 315MPa which is greater t

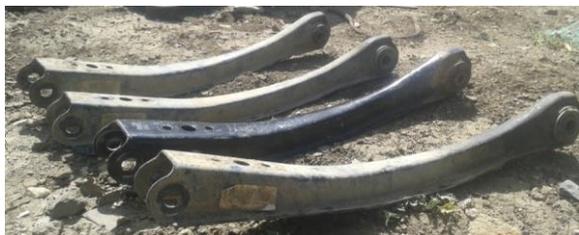
**Fig.1.** The existing damaged rear trailing arm

However, its customers are not fully happy due to the failure of some parts. Among the parts of suspension system which fails repeatedly is the rear trailing arm. It fails due to excessive deformation that tends to be straightened. As a result, the tyre wears quickly due to camber effect. The remedial action

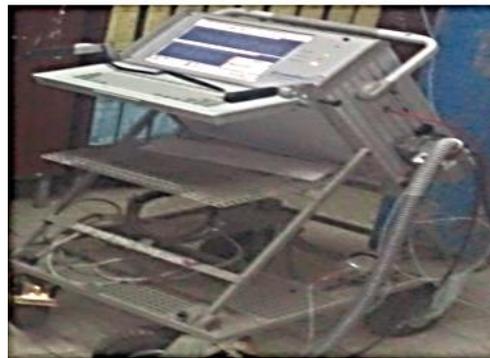
Fig. 5. Belec compact port spectrometry machine

The following steps were used for determination of the composition of the plate using spectrometer according to ASTM E 350 - 95 (Reapproved 2000) "Standard test methods for chemical analysis of carbon steel". Chemical composition analysis test instrument is depicted in Fig. 5 given below.

The composition analysis of the Rear Trailing Arm samples was carried out using Belec compact port spectrometric machine in MIE. The average composition weight percent results obtained from five specimens of five trials per each specimen and their detail trial results were tabulated. After testing, the obtained composition results for the materials are given in the Table 1 below.
