# Elimination of Soot and Rust from Nozzle Body In Order To Improve Quality and Productivity

Sagar Sonawane<sup>†\*</sup> and Poonam Walke<sup>‡</sup>

Accepted 12 March 2017, Available online 16 March 2017, **Special Issue-7 (March 2017)**

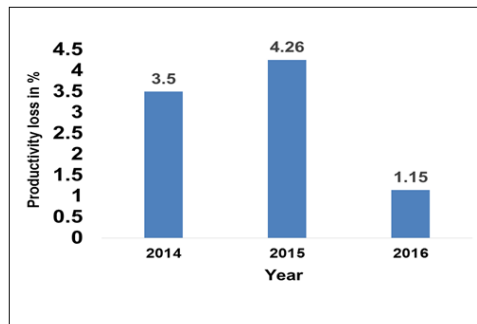
Fig.13 Result of Productivity

From above analysis changes and new development result in tremendous decrement in soot quantity parts. Below chart shows the result of soot and rust results in terms of quantity in terms of scrap cost and in terms of productivity. Also comparison with last 2 years data.

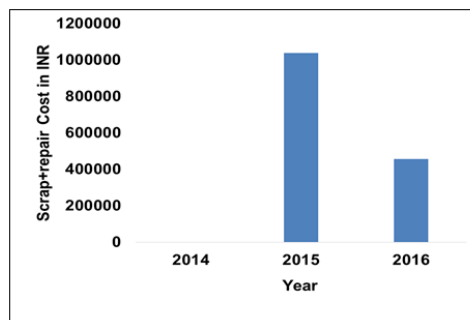
Fig.15 Comparison of overall cost of scrap and repair

Year	2014	2015	2016
Soot fallout after HT	73000	84500	107706
Scrap after repair		15798	4536
Scrap Cost	0	897010	257554
Productivity loss %	3.5	4.26	1.15
Repair cost	0	141960	198432
Scrap+Repair cost in INR		1038970	455986
